THE TSUNAMI OF NOVEMBER 29, 1975 IN HAWAII

HAROLD G. LOOMIS

DECEMBER 1975

HAWAII INSTITUTE OF GEOPHYSICS
UNIVERSITY OF HAWAII, HONOLULU

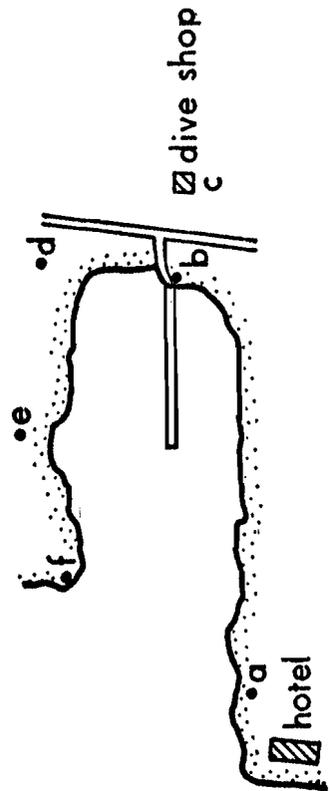
Location	Symbol ¹	Measurement		Approximate distance from water's edge		Correction		Evidence	
		Date	Time	Yards	Feet	Feet	Feet	Yards	Feet
Kona Surf Hotel, 50 yards inside south point of cove	a	12/4	1012	30	8.5	-0.2	8.3	Debris on grass	
Telephone pole at left side of parking lot	b	12/4	0910	3	7.8	+0.3	8.1	Paint marks high water on pole	
Dive shop and behind	c	12/4	0850	30	8.0	+0.4	8.4	Debris, high-water marks on building	
To right of cove, canoe storage behind wall	d	12/4	0930	50	9.2	+0.4	9.6	Debris	
Empty lot right side of cave	e	12/4	0930	30	8.6	+0.4	9.0	Do.	
North point of cove near Doc Hill's old house	f	12/4	0942	10	9.0	0	9.0	Debris on grass

Note: Boat at pier bottomed between first and second wave. One 20-foot boat was deposited on parking lot. A 36-40 foot boat was sunk. Other boats sustained minor damage.

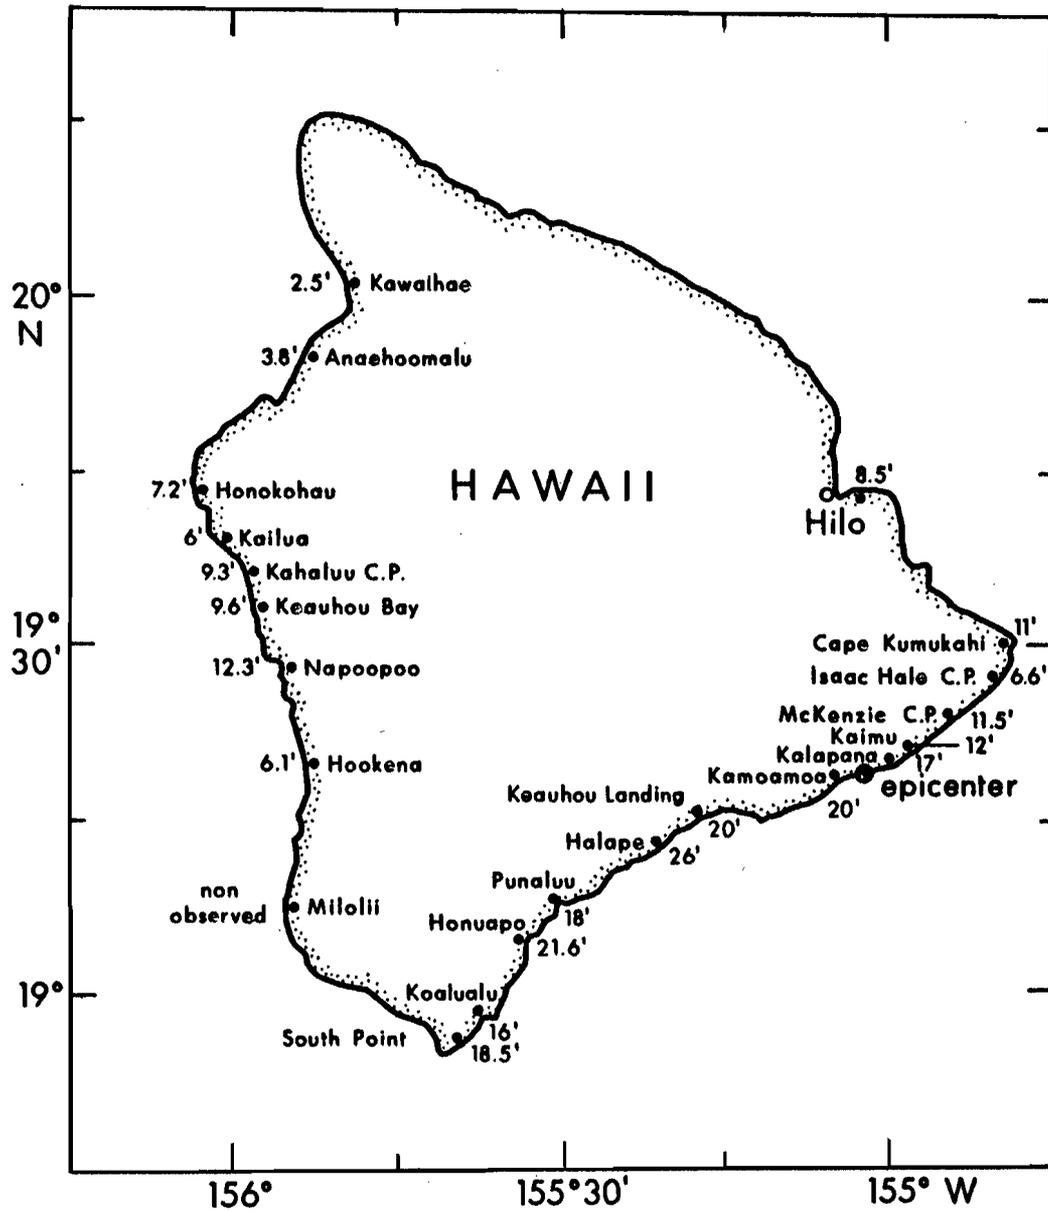
Figure 1. Maximum measured wave heights on the Island of Hawaii.

At 0448 Hawaii standard time on November 29, 1975, an earthquake of magnitude 7.2 on the Richter scale with epicenter at lat. $19^{\circ}20'$ N., long. $155^{\circ}01'45''$ W. generated a tsunami that did considerable damage in shoreline areas of the southern two-thirds of the Island of Hawaii (Fig. 1). The damage from the earthquake and tsunami combined was estimated by Hawaii County to be \$3-3/4 million; of that, about \$1-1/2 million damage could be ascribed to the tsunami alone. About a dozen dwellings were totally or partially destroyed, and a dozen boats were severely damaged.

The largest wave was 20 feet high and overran the shoreline just seconds after the earthquake at locations near the epicenter, which was 2-1/2 miles southwest of Kalapana or right at the shoreline at an unpopulated location called Kupaalu. In spite of the fact that the coastline was well populated with fishermen, campers, and surfers (it was the Saturday morning of Thanksgiving weekend), only two persons were killed. One of the victims was killed by a rockslide; because the body of the other has not been recovered, cause of death is unknown. These fatalities were from among a group of 36 campers at Halape in the Hawaii Volcanoes National Park. Most of the campers were caught

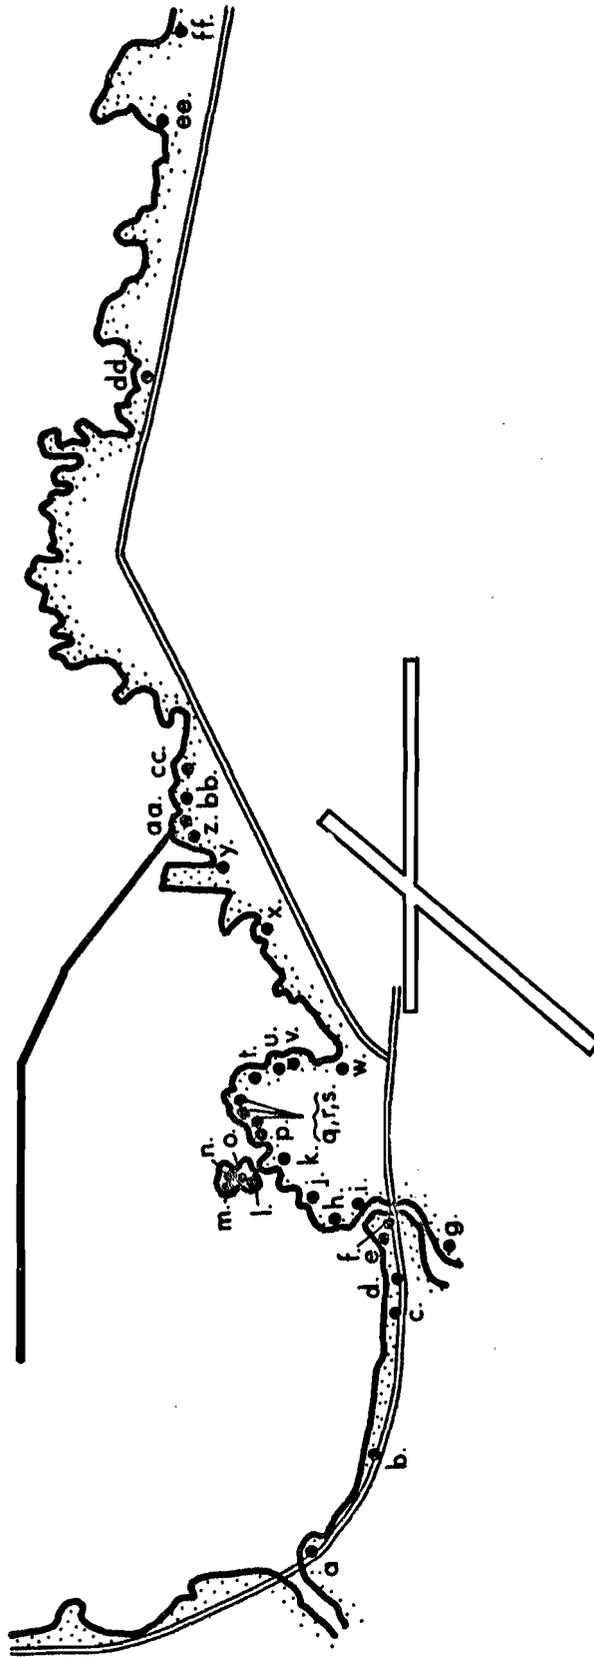
Figure 3. Location of measurements at Hilo; some symbols refer to Table 1.

Location	Symbol ¹	Measurement		Approximate distance from water's edge	Runup measurement		Correction		Evidence
		Date	Time		Yards	Feet	Feet	Feet	
Light at Wailuku River	a	11/30	1720	10	9.1	-0.6	8.5	Debris on ground	
Start of guard rail at intersection	b	11/30	1713	10	8.8	-0.6	8.2	Do.	
At canoe clubs	c	11/30	1635	20	7.9	-0.4	7.5	Do.	
100 yards east of symbol c	d	11/30	1640	20	7.9	-0.4	7.5	Do.	
Left bank entrance to Wailoa River	e	11/30	1705	20	8.8	-0.4	8.4	Do.	
Inside entrance, above parking lot	f	11/30	1655	20	8.3	-0.5	7.8	Do.	
At telephone stand, dock area, same level along docks	g	11/30	1615	5	5.5	-0.4	5.1	Silt on cement base of telephone stand	
Marine railway by Suisan	h	12/1	0950	15	7.7	-0.7	7.0	Debris on tree	
Rock wall toward river, inside at Suisan	i	12/1	1000	5	5.8	-0.7	5.1	Debris in rock wall	
Rock wall by Liliuokalani Garden	j	12/1	0930	10	5.1	-0.8	4.3	Debris	
To left of road leading to Coconut I.	k	12/1	1710	30	4.6	+0.2	4.8	Debris, log

Coconut I. bridge	l	12/1	1735	40	5.0	0	5.0	Debris, seaweed	
Seaward side of comfort station	m	12/1	0740	8	7.4	0	7.4	Seaweed in trees	
Seaward right side of Coconut I.	n	12/1	0745	10	6.6	0	6.6	Debris on grass	
Water just tops wall	o	12/1	0750	1	6.1	0	6.1	Debris	
Right of road to Coconut I.	p	12/1	0725	20	5.5	0	5.5	Debris, seaweed	
Front of Hilo Lagoon Hotel	q	12/1	0630	5	4.1	+0.4	4.5	Debris

Location	Symbol ¹	Measurement		Approximate distance from water's edge	Runup measurement		Correction		Corrected measurement		Evidence
		Date	Time		Yards	Feet	Feet	Feet	Feet	Feet	
Front of Hilo Lagoon Hotel	r	12/1	0815	5	4.3	0	4.3	0	4.3	Debris	
Front of Hilo Lagoon Hotel	s	12/1	0815	5	4.3	0	4.3	0	4.3	Do.	
Naniloa Hotel	t	12/1	0832	5	4.0	-0.3	3.7	-0.3	3.7	Do.	
Naniloa Hotel	u	12/1	0845	5	4.7	-0.4	4.3	-0.4	4.3	Do.	
Naniloa Hotel	v	12/1	0850	5	2.8	-0.4	2.4	-0.4	2.4	Do.	
Reeds Bay, by road	w	12/1	0910	10	4.3	-0.7	3.6	-0.7	3.6	Do.	
West of pier 2, 50 yards	x	12/1	1120	5	3.6	-1.2	2.4	-1.2	2.4	Do.	
Radio Bay at Coast Guard Cutter	y	11/30	1343	0	3.5	-0.4	3.1	-0.4	3.1	Testimony followed by measurements. "Boats bottomed during wave."	
East end of Radio Bay	z	11/30	1400	10	3.3	-0.4	2.9	-0.4	2.9	Debris on grass. Pine needle swash marks.	
Just outside breakwater	aa	11/30	1415	10	6.9	-0.4	6.5	-0.4	6.5	Do.	
Outside breakwater, 100 yards east	bb	11/30	1430	10	6.7	-0.4	6.3	-0.4	6.3	Do.

Outside breakwater, 200 yards east	cc	11/30	1435	10	6.8	-0.4	6.4	-0.4	6.4	Do.	
James Kealoha Park	dd	11/30	1352	5	4.7	-0.4	4.3	-0.4	4.3	Bagasse, flattened grass	
Leleiwi Park	ee	11/30	1530	20	5.5	-0.4	5.1	-0.4	5.1	Swash in pine needles	
End of road, 4 miles	ff	11/30	1520	30	6.0	-0.4	5.6	-0.4	5.6	Do.

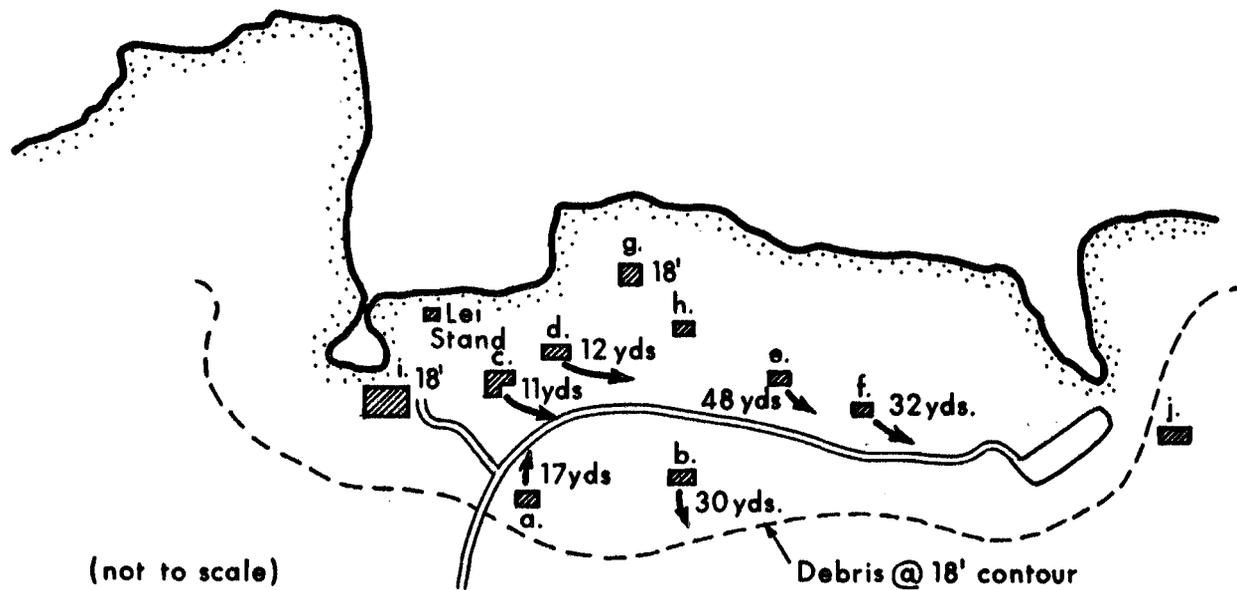
Figure 4. Punaluu, Kau, Hawaii showing houses destroyed.

- a. Ito house destroyed, moved 17 yards toward sea.
- b. House nearly intact, moved 30 yards inland.
- c. Dahlberg house, mostly destroyed, rotated 90° clockwise, moved 11 yards to right then seaward 5 yards.
- d. Carmichel A-frame house destroyed, moved 12 yards to right.
- e. Mizuno house shattered, moved 48 yards,
- f. Cacholoa house shattered, moved 32 yards.
- g. Pavilion fence down and roof lifted.
- h. Small tile buildings destroyed.
- i. C. Brewer restaurant gutted.
- j. Golf house basement filled, golf carts flooded.

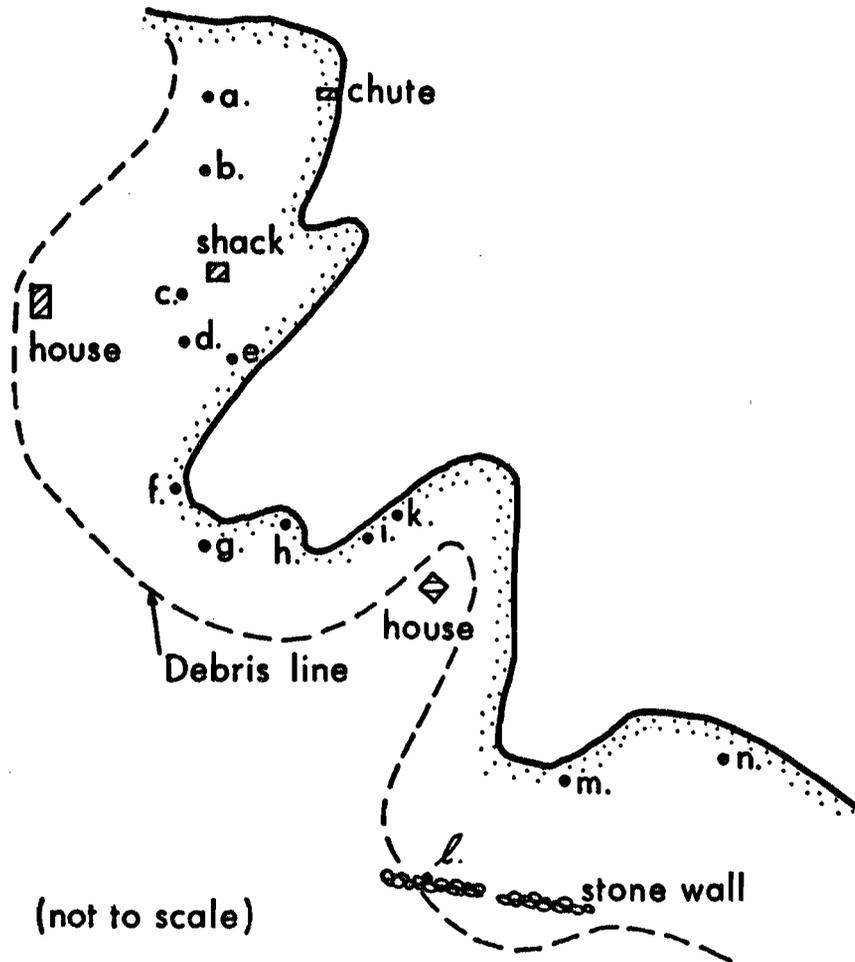
Figure 5. Kaalualu, Kau, Hawaii showing locations of measurements.

Kaalualu ⁴	12/3	0800-1200	-	-	-	16.0			Debris all around cove.

Location	Symbol ¹	Measurement		Approximate distance from water's edge	Runup measurement		Correction		Corrected measurement		Evidence
		Date	Time		Yards	Feet	Feet	Feet	Feet	Feet	
Kaalualu	a	12/3	0950	80	15.0	-0.6	14.4	Debris			
Kaalualu	b	12/3	0940	50	14.3	-0.5	13.8	Keawe tree marks			
Kaalualu	c	12/3	0935	40	16.4	-0.4	16.0	Do.			
Kaalualu	d	12/3	0930	20	14.8	-0.4	14.4	Do.			
Kaalualu	e	12/3	0932	10	14.9	-0.4	14.5	Do.			
Kaalualu	f	12/3	1002	2	12.0	-0.6	11.4	Do.			
Kaalualu	g	12/3	1010	5	13.2	-0.6	12.6	Do.			
Kaalualu	h	12/3	1018	5	13.5	-0.7	12.8	Do. (near wrecked boat)			
Kaalualu	i	12/3	1027	5	9.8	-0.8	9.0	Keawe tree marks			
Kaalualu	j	12/3	1036	40	11.8	-0.8	11.0	Do.			
Kaalualu	k	12/3	1146	60	11.1	-0.9	10.2	Do.			
Kaalualu	l	-	-	200				Stone wall knocked down			
Kaalualu	m	12/3	1125	5	15.2	-0.8	14.4	Keawe tree marks			
Kaalualu	n	12/3	1133	80	16.0	-11.0	15.0	Debris on grass
