Dyson 20-12 Mooring Report

Sarah Donohoe and Catherine Berchok

22 December 2020

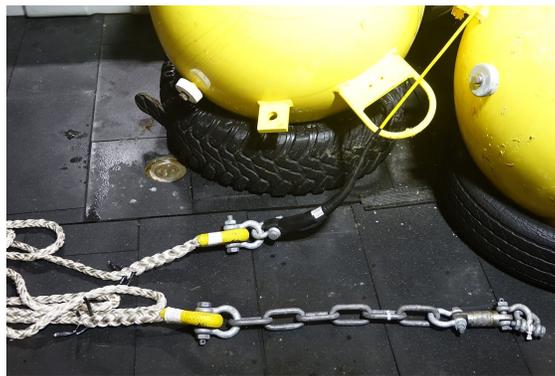
NRS1 – When deploying this mooring, there was a 10m section instead of a 47m section. Didn't realize this until the full spool was wound onto the net reel for deployment, and we found the 10m section, connected to a 1m chain with a swivel that looked like it should be at the anchor-end of the mooring. At that point it was questioned whether the entire mooring line was placed onto the spool backward, so the slow process of rewinding the line onto the spool was conducted before the other end of the line was visible on the net reel and determined to be short as well.

- 1. Missing .25 meter (3 links) chain below the first SBE-37 at 353 meter depth*
- 2. Swapped 47 meters 3/4" Nylon with 10 meters of 3/4" Nylon and an extra 1.5 ton swivel*
- 3. An extra 5/8" SL pear-link above the Haruphone at 500 meter depth*

Figure 3. NRS1 10m nylon section attached to 100m vectran, and 1m chain with swivel at the float-end of the mooring. This photo was taken before we removed the swivel, broke the chain to 3 links length and shackled in the SBE37 according to the diagram (shown in Figure 4.)

I have annotated the mooring diagram with what changes there were. I've also got photos of the swapped nylon section with a swivel. We ended up cutting a piece of extra chain for the 3 links we needed below the shallowest SBE. Ryan and I called Geoff to confirm that the 10 meter section of nylon above the Haruphone and the 100 meter section of vectran was going to be ok... as opposed to the 47 meters that should have been there. We got the ok to deploy with that change, which only affected the actual depth of the shallowest SBE and the 75 kHz ADCP.

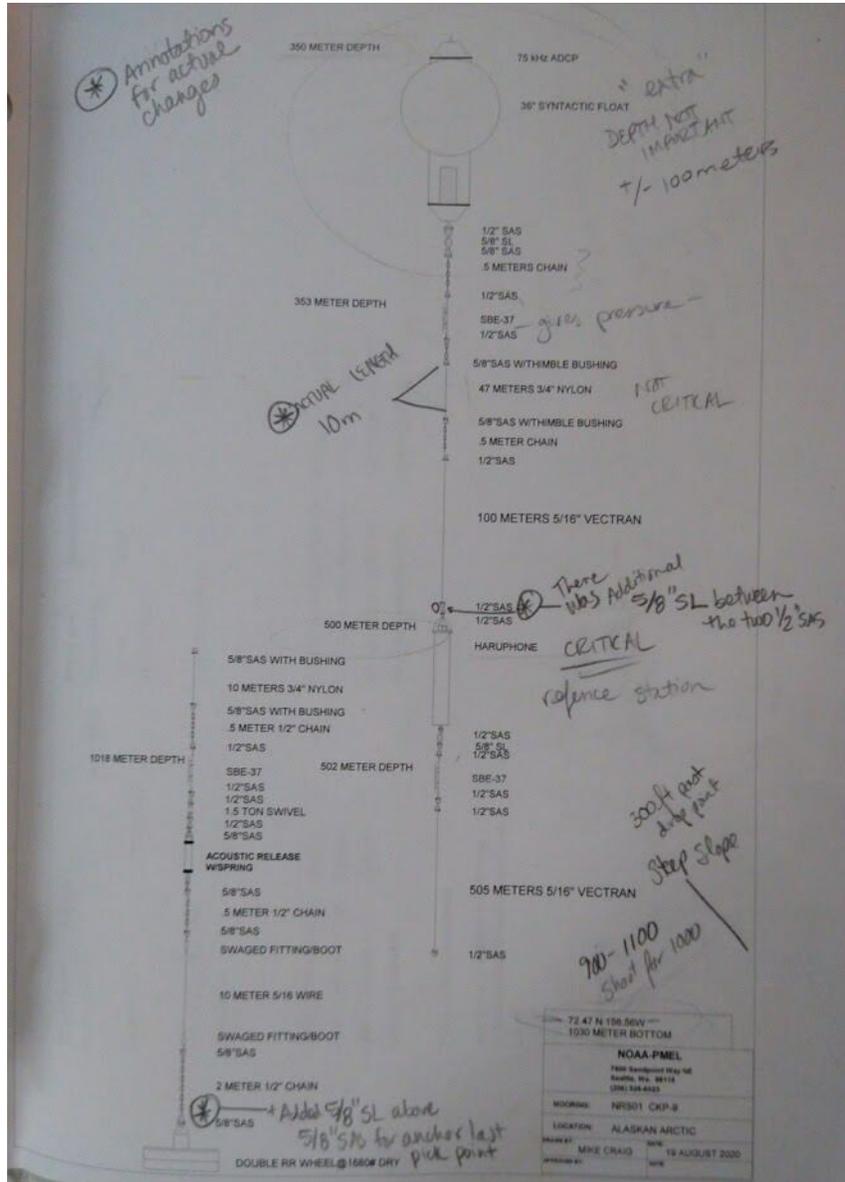
Figure 4. Annotated NRS1 diagram.

We also had to add a 5/8" SL pear-link right above the anchor as a pick-point for the anchor-last deployment.
