NOAA Pacific Marine Environmental Laboratory  
Ocean Climate Stations Project

## TECHNICAL NOTE 4.1

# Capacity Issue with AA Li Batteries in SBE37's

# Seabird SBE37 Battery Failures on KE014

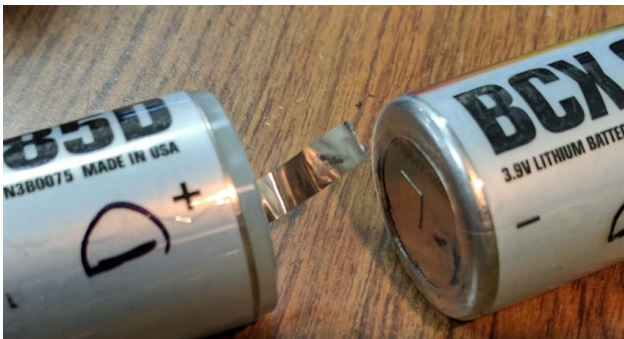
When removing the old batteries from the failed sensors to prepare for testing, an important discovery was made. The metal tab that connects the two D-cells inside the pack had separated on all seven of the failed instruments from KE014. Four of the tabs had broken at the weld to the top of the battery, and on three instruments the tabs themselves broke in the middle. No broken tabs were found on any other instruments that did not experience early failure. These broken tabs were presumably caused by vibrations in the mooring line causing repeat strain on the relatively thin connection between cells.

Poor or intermittent contact between the cells would almost certainly have a negative effect on battery performance. Charring was found on a number of the batteries indicating arcing between the cells due to a broken connection.

Figure 1. Broken Tab Between Cells

With no clear indication that there is, or ever was, an inherent issue with the AA lithium battery packs designed to power SBE37s, it is recommended that OCS revert instruments back to original AA configuration. OCS has conferred with the Global Tropical Moored Buoy Array (GT MBA) and the National Data Buoy Center (NDBC), both of whom use 100's of AA powered SBE37's across dozens of buoys. Neither agency has reported any abnormal trends of battery failure.

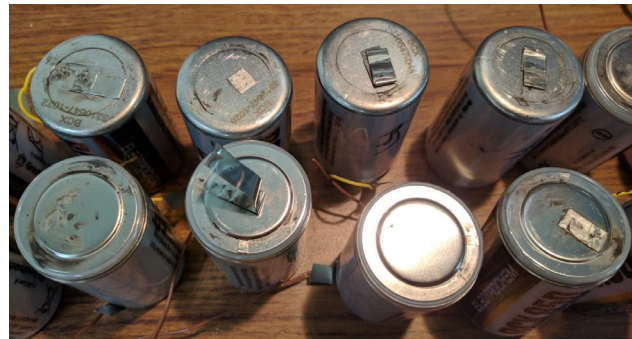
Figure 2. Broken Tabs & Welds

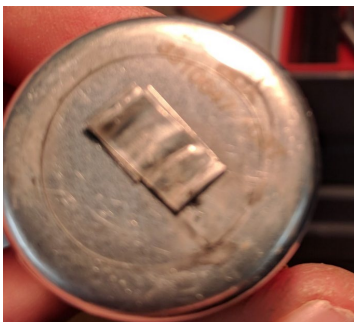
Figure 3. Broken Tab

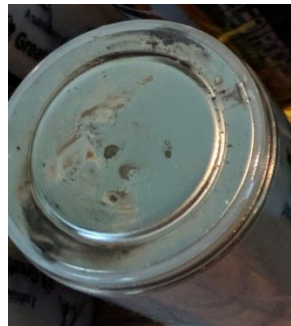
Figure 4. Broken Weld, Scorching
