NOAA Pacific Marine Environmental Laboratory
Ocean Climate Stations Project

TECHNICAL NOTE 5

Wind Speed Variability of Vaisala WXT520

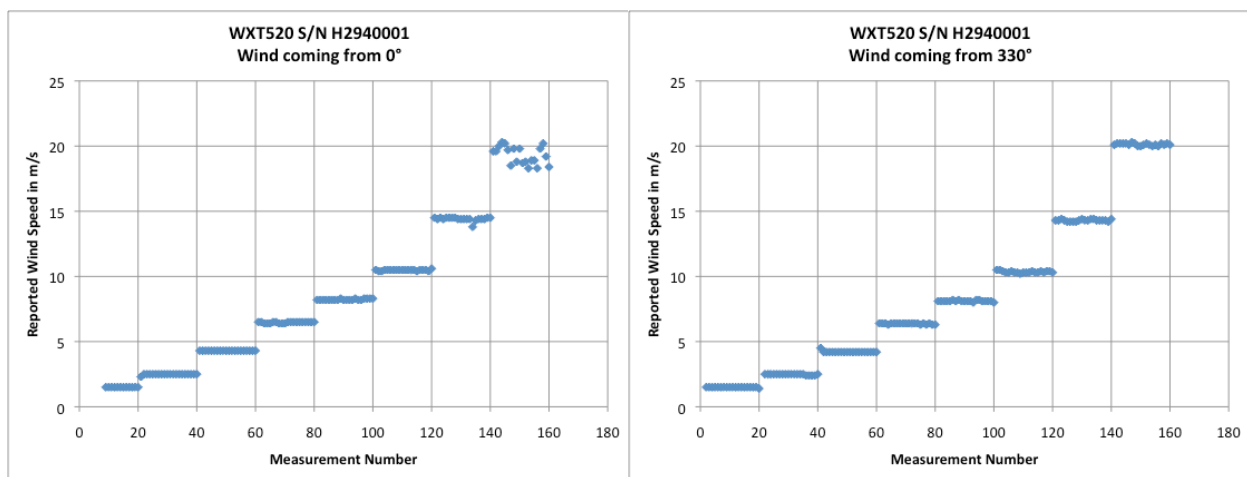
The plots below show the raw output of sensor S/N H9240001 during wind tunnel testing. On the left, the wind was incident from 0°. On the right, the sensor was rotated off North by 30°. When the wind is not coming directly from 0°, the readings at higher wind speeds stabilize. This was noted by Vaisala while addressing the initial service request.

Figure 1: Vaisala WXT520 wind speed output as tested in a wind tunnel. Wind incident from 0° (left) and 330° (right).

In August 2012, it was recommend that all future purchases of the Vaisala WXT520 be halted completely, until it could be guaranteed that a solution to the erratic wind speed readings has been found and implemented. Vaisala was notified of this decision.

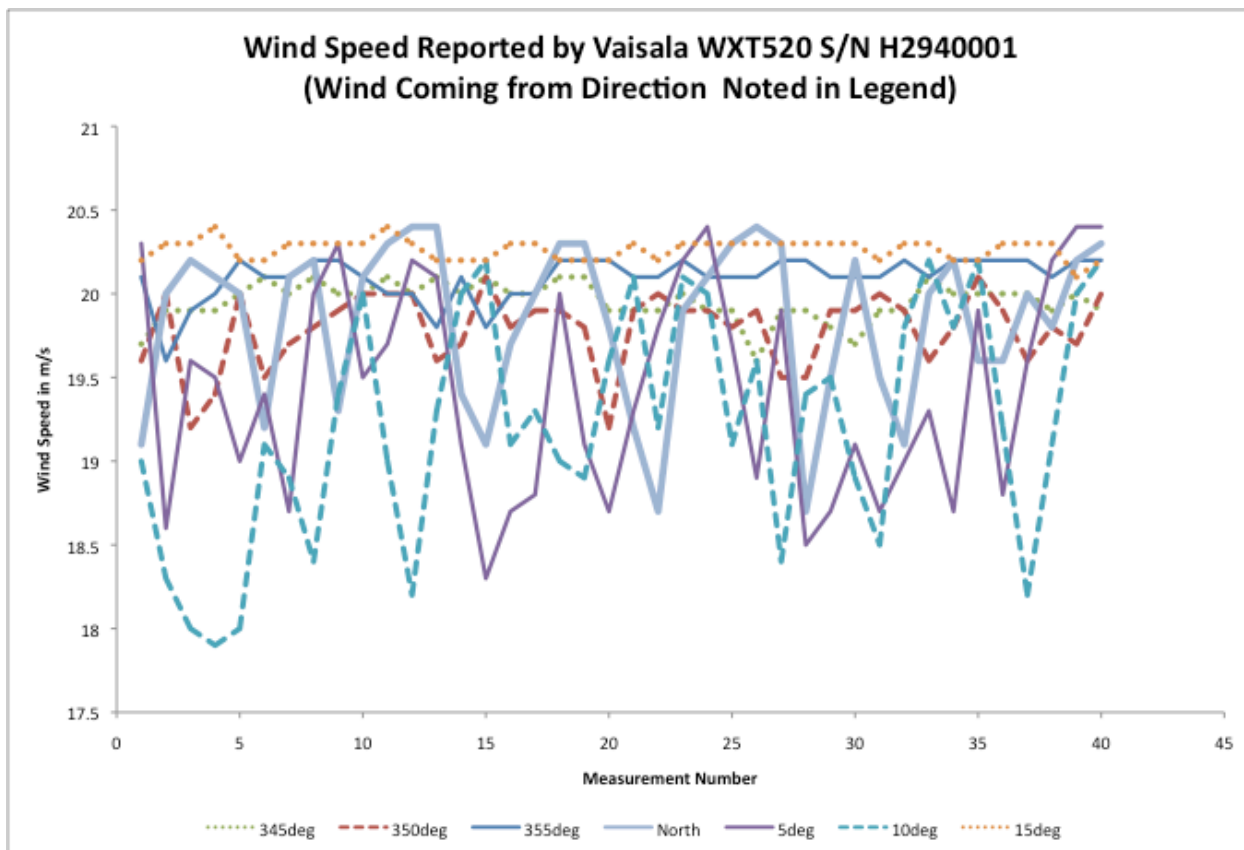
Further testing was done to determine the angle either side of North at which the speed measurements become steady. On September 5, 2012, sensor S/N H2940001 was tested in the wind tunnel at a wind speed setting of 19.5m/s. Forty readings were logged at various angles.

Winds from the NW were found to be more erratic than from the NE. By 15° off N in either direction, the spread of wind speed readings fell within the accuracy specifications of the instrument ($\pm 3\%$). The speeds were more erratic at 10° than 5° on either side of North.

Figure 2: Vaisala wind speed readings at wind tunnel setting of 19.5m/s. Incident wind directions noted in legend.

North	355°	350°	345°	5°	10°	15°
Min	18.7	19.6	19.2	19.6	18.3	17.9	20.1
Max	20.4	20.2	20.1	20.1	20.4	20.2	20.4
Spread	1.7	0.6	0.9	0.5	2.1	2.3	0.3
