NOAA Pacific Marine Environmental Laboratory
Ocean Climate Stations Project

TECHNICAL NOTE 8

Flex Battery Depletion in PA006 Mooring

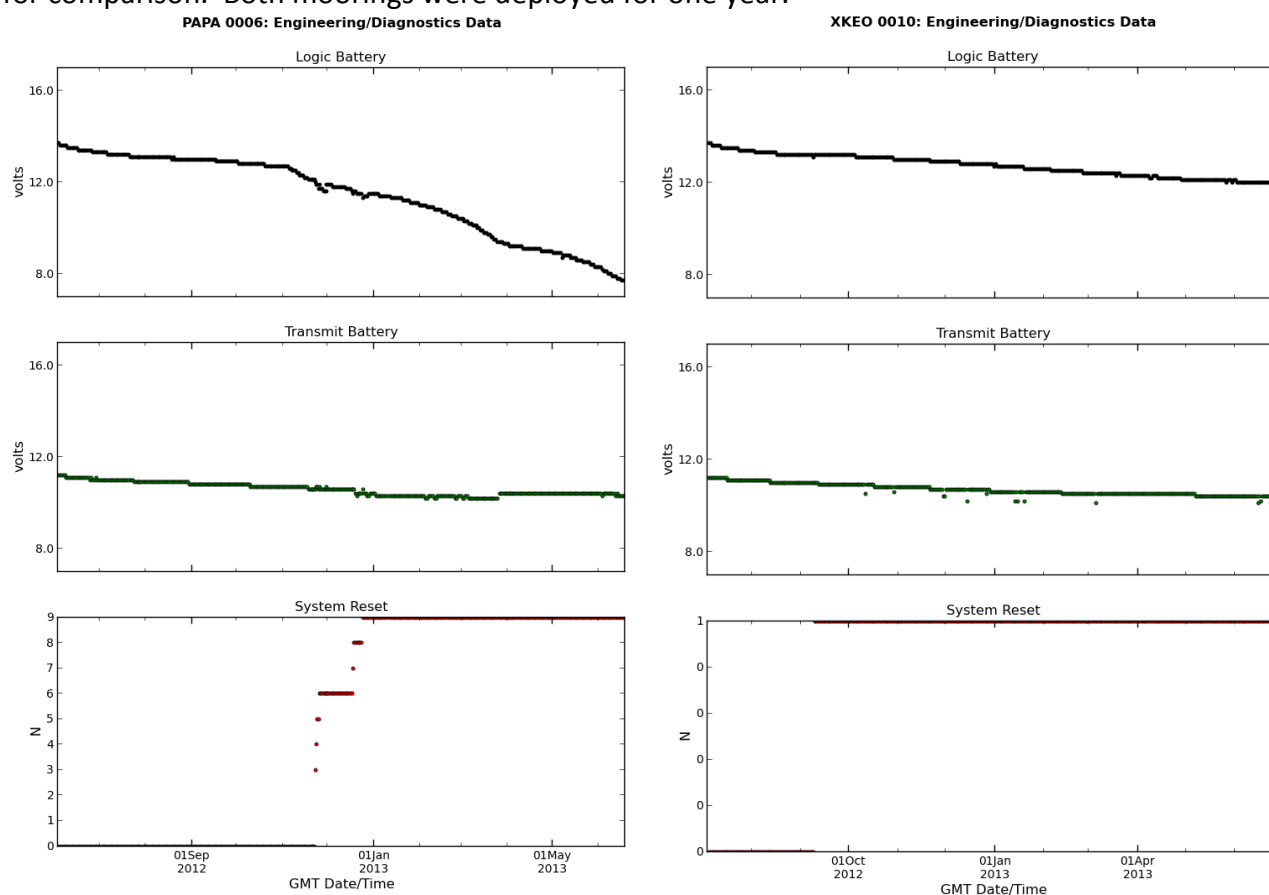
Figure 1: PA006 (left) and KE010 (right) battery voltages and system reset plots for one year deployments.

In the top panels of Figure 1, the Logic battery voltage of PA006 shows a steep decline. The Logic battery supplies power to the meteorological instruments and Flex data acquisition processes. At the beginning of the deployment, the Logic battery voltage was 13.7V. At the time of recovery, the voltage had dropped to 7.7V, compared to 12.0V for KE010.

The first sharp decline of the PA006 Logic battery voltage occurred around November 5, 2012. This was followed by a short string of system resets, which began on November 22, 2012. In previous deployments, system resets and high battery drain were found to be associated with water intrusion in the buoy well. Upon recovery, the PA006 well was dry.

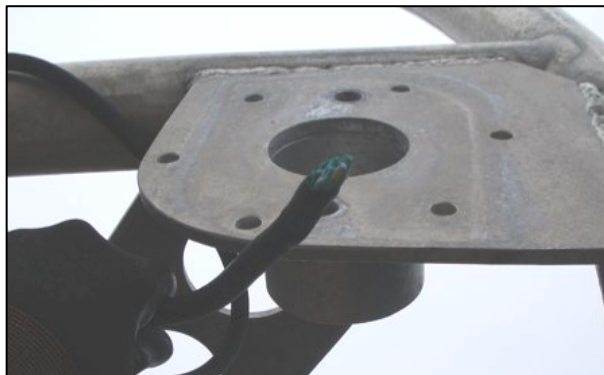
When the PA006 mooring was recovered, it was missing a sensor from the tower. The Vaisala WXT520 combination weather sensor was gone, along with its mast and mounting plate. The cable was sheared off and corroded, shown in Figure 2. Since this combination instrument includes a rain sensor, the Flex system continuously supplies power from the logic battery. The instrument stopped returning real time data on October 16, 2012, and the internal compass stopped on October 17, 2012. The instrument may have been damaged and dangled from the tower for a period before falling off.

Figure 2: Sheared cable of missing Vaisala.

The sheared cable from the Vaisala sensor was constantly receiving power from the Logic battery through the Flex system. Exposure to water on the bare wires would cause a direct short, draining power. The corrosion of the Paros connectors may also have been caused by shorting due to moisture, which might lead to additional power drain. These sources likely caused the excessive drain of the Flex Logic batteries.

Instruments deployed in the field sometimes perform erratically, with data coming in and out. If an instrument stops reporting real time data entirely for a period longer than one week, it is recommended that a new system calibration file be sent to the Flex system via Iridium, with that sensor removed. This will stop the Flex system from supplying Logic battery power to that instrument.

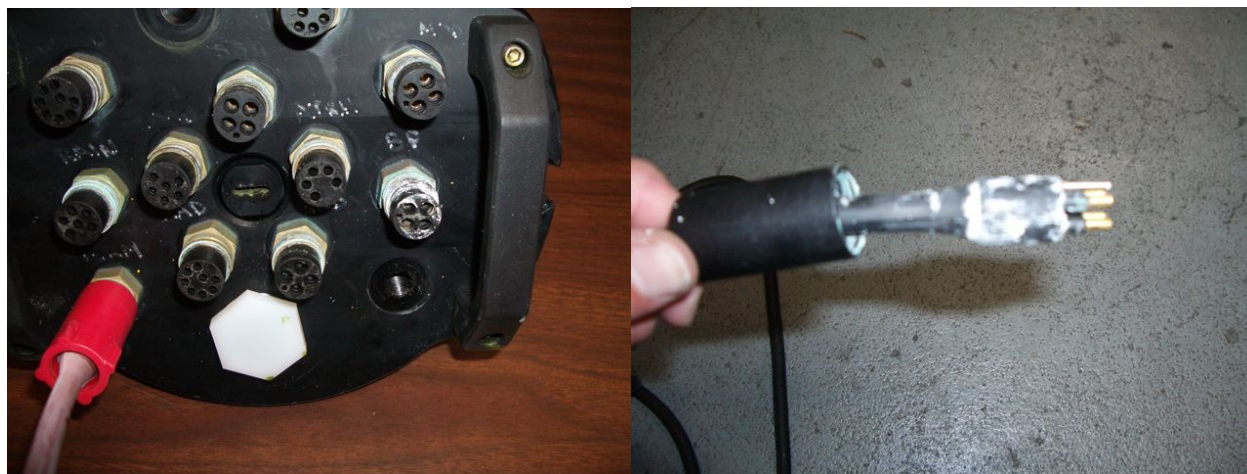
When the buoy was returned to the lab, it was fully disassembled and inspected. At this time, corrosion was noted on the mating connectors for the Paros barometric pressure sensor at the Flex faceplate, shown in Figure 3. The Paros reported good data throughout the deployment.

Figure 3: Corroded mating connectors of Paros barometric pressure sensor.

All connectors should continue to be inspected and greased at the time of deployment to ensure that moisture does not enter the connection and cause a short.
