Dyson 20-12 Mooring Report

Sarah Donohoe and Catherine Berchok

22 December 2020

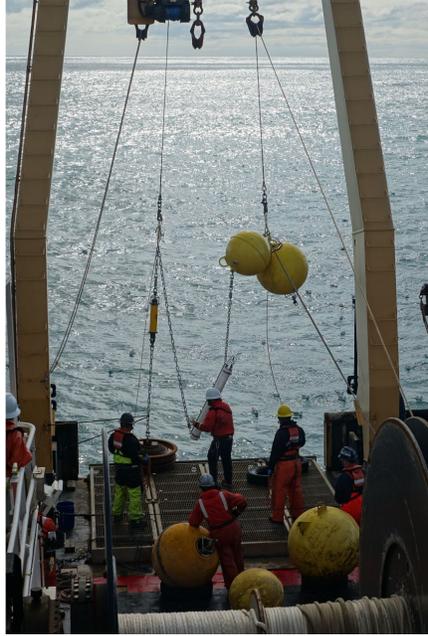
The bosun decided to try a new system of deploying these mooring, that involved using the outhaul to pick above the release with a quick release, and the float on another quick release using the net reel. The entire mooring was then lifted in a large 'N' (Fig. 1). The Bosun found this to be much more safe than to use the deck chain to stopper off sections. The only part that was a bit sketchy is that no pin was used in the quick release for the float – a deckhand would just keep the release line slack. This same method (in reverse – and without the quick releases) was used to recover the larger oceanographic moorings for the same reason (Fig. 2).

Figure 1. Mooring deployment in 'N' shape.

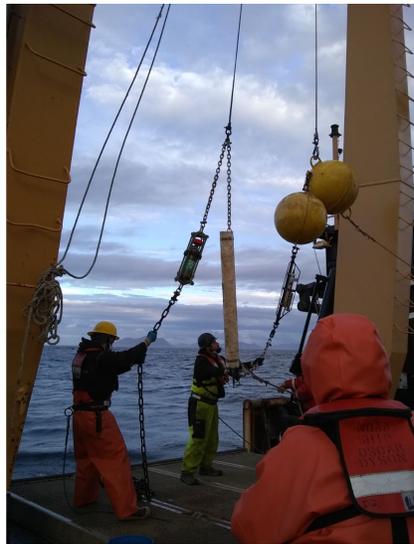
Figure 2. Mooring recovery in 'N' shape
